# Berryessa Creek Element Coyote and Berryessa Creeks Flood Control Project Santa Clara County, California

**Appendix D: HTRW Assessment**

# HAZARDOUS, TOXIC AND RADIOACTIVE WASTE PHASE I ENVIRONMENTAL SITE ASSESSMENT

# BERRYESSA CREEK FLOOD CONTROL PROJECT MILPITAS, CALIFORNIA

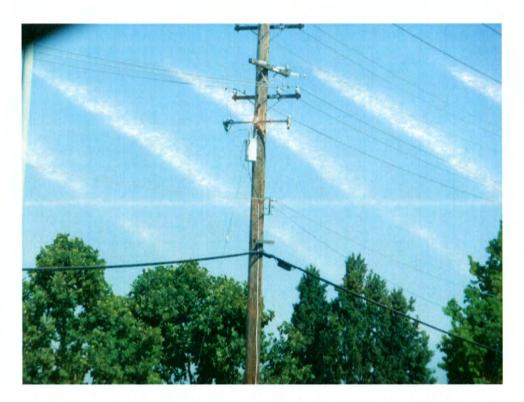
- 7. There are many instances of transformers in the region studied. Several examples of these are shown in figures 1-4. None of them is considered to be a REC, partly because they appear to be in good condition, secure, either by height above ground or by locked cabinets, and because they no longer contain PCBs (Ref 5).

Figure 1. Tank-type transformer, pole-mounted. Blue label near bottom left of tank indicates PCB-free.

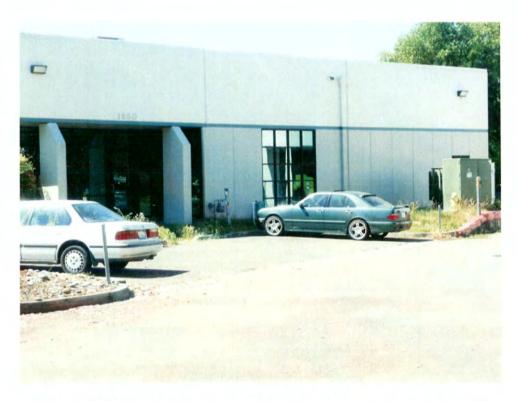
Figure 2. 1650 Watson Ct. Ground-mounted transformer to the right (typical).

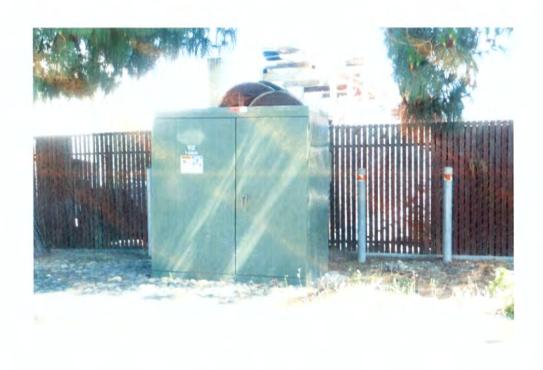
Figure 3. Ground-mounted transformer #T1142 near 1658 Watson Ct.

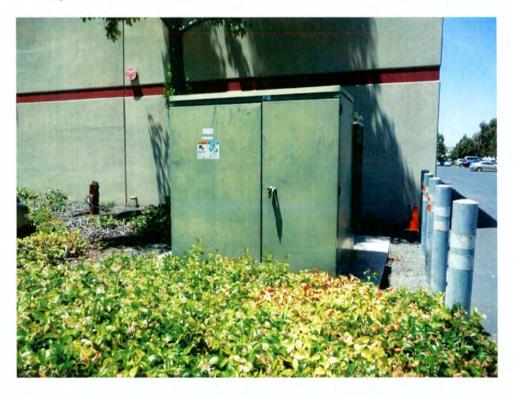
Figure 4. A ground-mounted transformer located near creek at 682 S. Hillview Dr., TDK Headway Technologies, Inc.

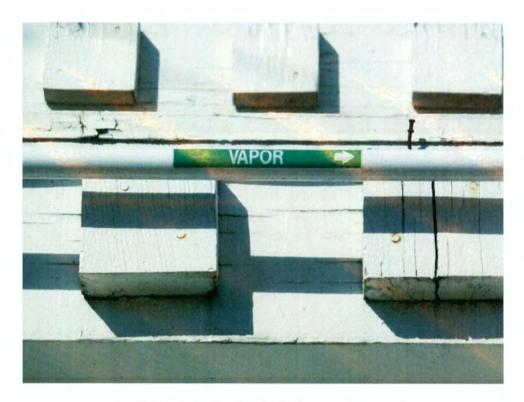
- Two gas stations (EDR #2 and # 58), which had historical releases, but the environmental sites are considered closed or no further action (NFA) is warranted (Figures 5-8 and Ref 5).

Figure 5. Return line for the fuel waste vapor tank.

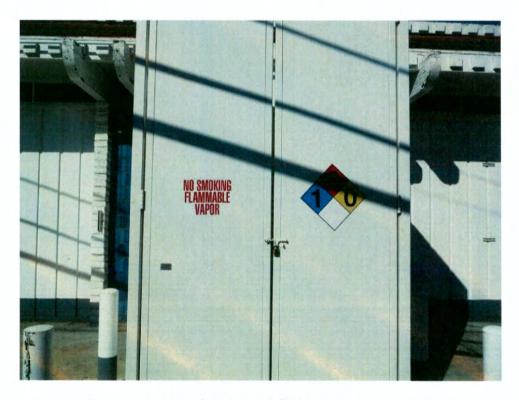
Figure 6. Waste Fuel Vapor Tank (behind secure enclosure).

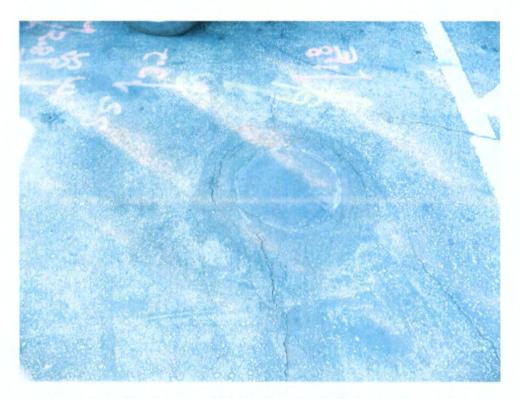
Figure 7. Repaired road surface where old UST may have been located.

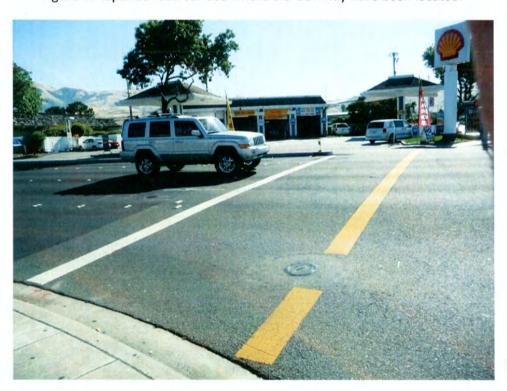
Figure 8. Overview of Shell Oil Co.

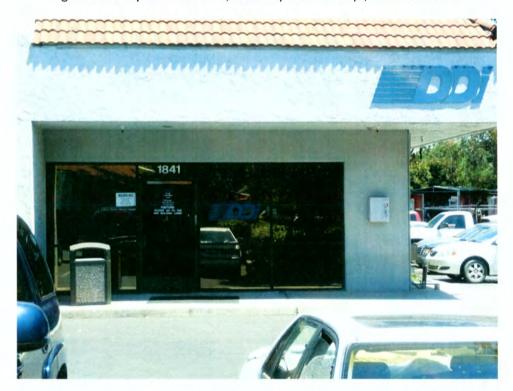
- 2. Four industrial sites that had been listed as having releases (Ref 5) but have changed hands since the listing. These are DEVCON Construction Co.(EDR #10), which is now Grace Alliance Church (Figure 9), COMAC (EDR #24), now Iron Mountain Co. (Figures 10-11), Landmark Labels (EDR #49), now Emotion Co. (Figure 12), Intersil Corp. (EDR #62), now Peoples Associates (Figure 13), and "Industrial Building" (EDR #62), now DDI (Figure14).

Figure 14. 1831-1841 Tarob Ct., DDI, formerly "Industrial Building"

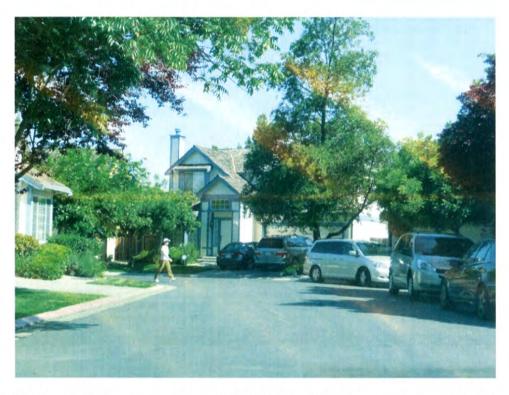
- 3. One residential site (EDR #42) was reported to have a release (Ref 5), presumably during construction, but this is not currently evident (Figure 15), since the construction phase is complete and homes occupy the site. The site, located at 1260 Dempsey Rd, east of Interstate 680, is under land use controls. While this is counted as a REC, it is not considered to be close enough to affect the proposed project at Berryessa Creek.

Figure 15. Stonegate residential development. No RECs apparent, however land use controls in effect.

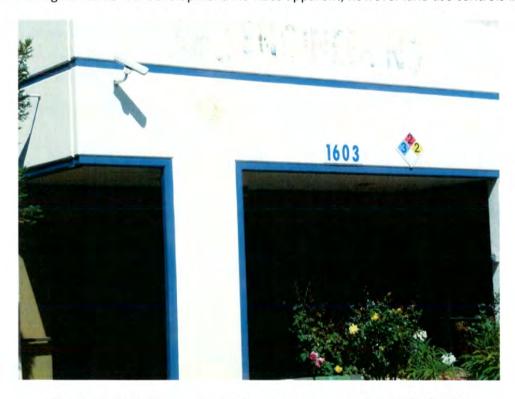
- 4. Three industrial sites were listed as having released a HS and are still under the same company name: Flex Interconnect (EDR #49, Figures 16-19), Vector Fabrication/KML Engineering Corp. (EDR #49, Figures 21-22), and Cordova Printed Circuits (EDR #49, Figures 23-24). These facilities were located all in the same court. Although they backed up to the creek, these facilities now are clean and exhibit no threat of a release.

Figure 16. 1603 Watson Ct. Flex Interconnect, case closed 4/12/2000.

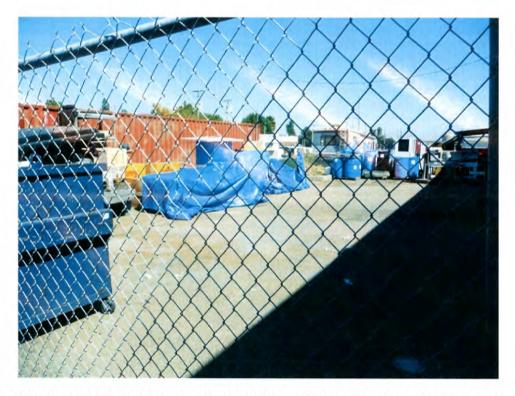
Figure 17. Flex Interconnect 1603 Watson Ct. Back of bldg. Flammables cabinets, drums marked empty.

Creek is to the rear of the cabinets.

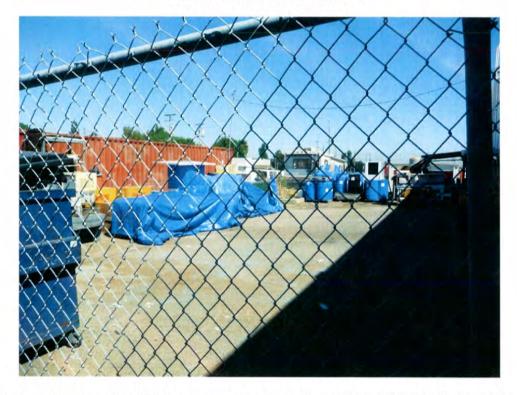
Figure 18. Flex Interconnect 1603 Watson Ct. Back of bldg. Flammables cabinets, drums marked empty.

Creek is to the rear of the cabinets.

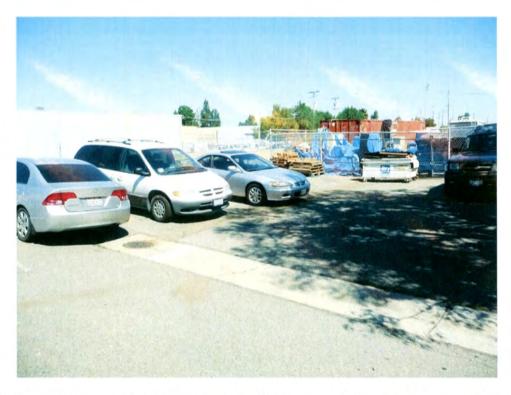
Figure 19. Flex Interconnect 1603 Watson Ct. Back of bldg. View to show location of creek, behind cars.

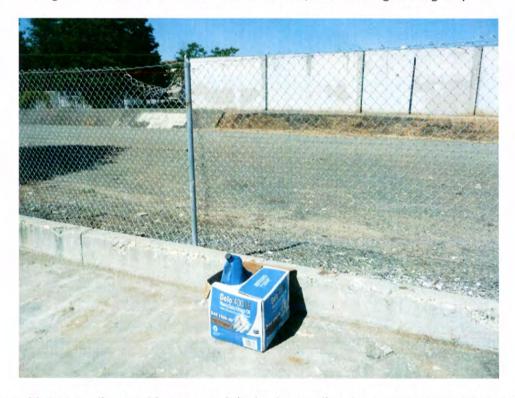
Berryessa Creek runs through developed commercial and residential areas in Milpitas, California. The creek is generally well-maintained and free from dumping of discarded items, although the site reconnaissance team found evidence that one gallon of waste antifreeze was thrown into the creek (Figure 33) and a box of waste petroleum products was discarded on the pavement adjacent to the creek (Figure 22).

Figure 22. Waste oil cast aside near creek (in background). In lot next to Vector Fabrication.

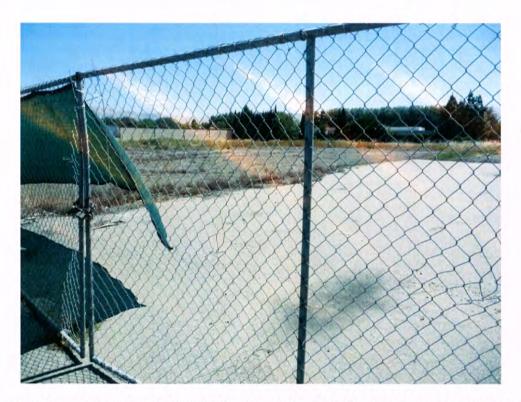
- 5. One listed site, Kaiser Experimental Labs (EDR #56), 1600 S. Main St., could not be located, but the presumed address is now a vacant lot (Figures 25-27). This site shows signs of distressed vegetation, which is a REC, but it is fairly distant from the creek, and will not likely affect construction.

Figure 25. Kaiser Experimental Labs, 1600 S. Main St., could not be located. This is the apparent location, now an empty lot, which is fenced off. Note the distressed vegetation. #1 of 3

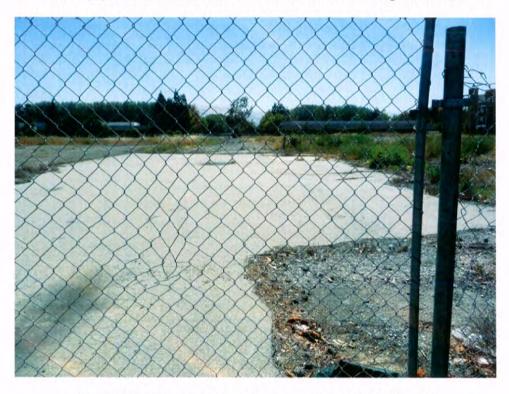
Figure 26. Kaiser Experimental Labs, 1600 S. Main St. #2 of 3

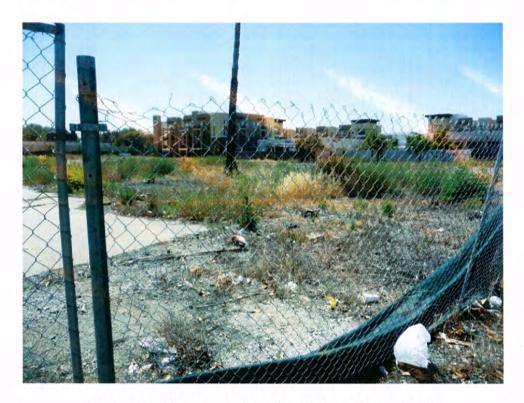
Figure 27. Kaiser Experimental Labs, 1600 S. Main St., #3 of 3

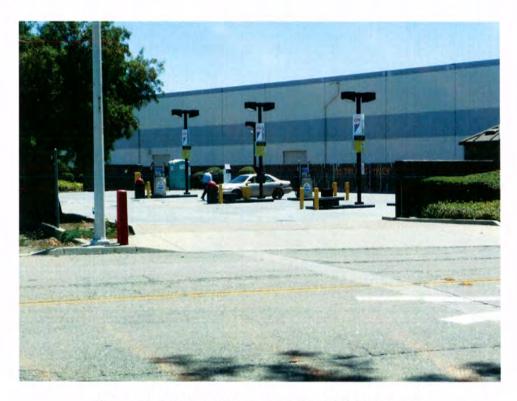
- Other sites investigated, but were not listed in the EDR Report, include a CFN Gas Station, which is located within 100 feet of the creek (Figure 28), a distribution plant, which has an AST and a UST on site (Figures 29-30), a processing plant, which has five USTs (Figures 31-32).

Figure 28. CFN Gas Station. USTs about 60' from creek.

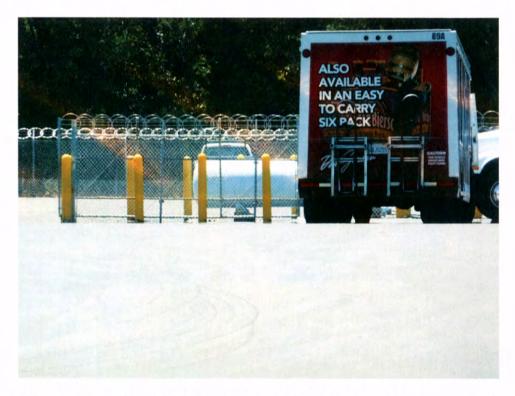
Figure 29. AST, possibly a propane tank, located about 700' from creek at Bottomley Distributing Co., 755 Yosemite Dr.

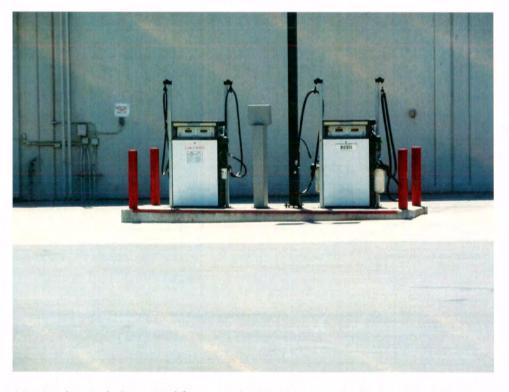
Figure 30. UST, located about 500' from creek at Bottomley Distributing Co., 755 Yosemite Dr.

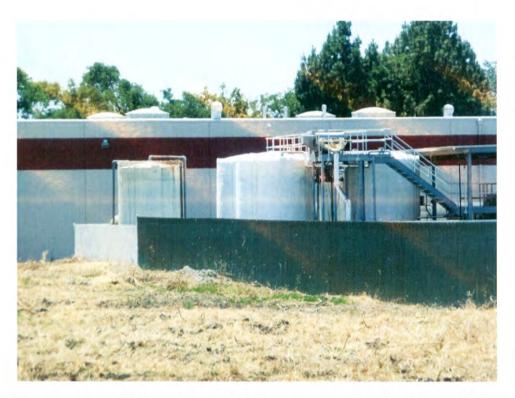
Figure 31. Five white plastic ASTs, located about 500' from creek, containing unknown liquid. Tanks are in operation and are secured behind fence.

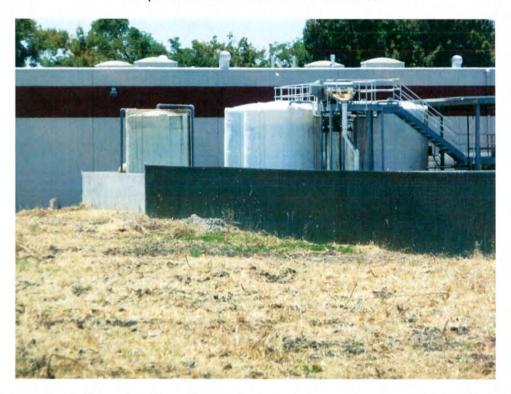
Figure 32. Five white plastic ASTs, located about 200' from creek, containing unknown liquid. Tanks are in operation and are secured behind fence. (Second view)

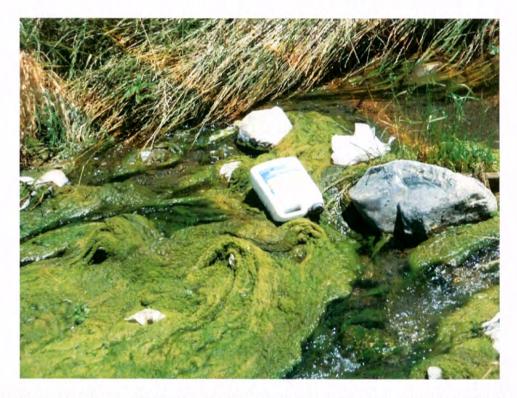
- 8. The final segment of the reconnaissance involved walking along the creek. The creek and the immediate surroundings appear to be routinely maintained, since only two instances of discarded materials could be found (Figure 33). The 1-gallon container of antifreeze is not considered to be a REC due to its small size, and it was empty or nearly empty. There are a few bridges and a few power transmission lines that cross the creek (Figures 34-37). The properties that are immediately adjacent to the creek consist mostly of commercial structures, but there are also a few residential neighborhoods in the

Figure 33. A rare instance of HW discarded into the creek. In this case, one gallon of antifreeze.
